# **2020.0659-RP01- IMPROVING THE WATER QUALITY OF EMILY BAY, NORFOLK ISLAND**

## **REPORT**

Company. Parks Australia  
Date. 20 November 2020  
Job Number 2020.0659

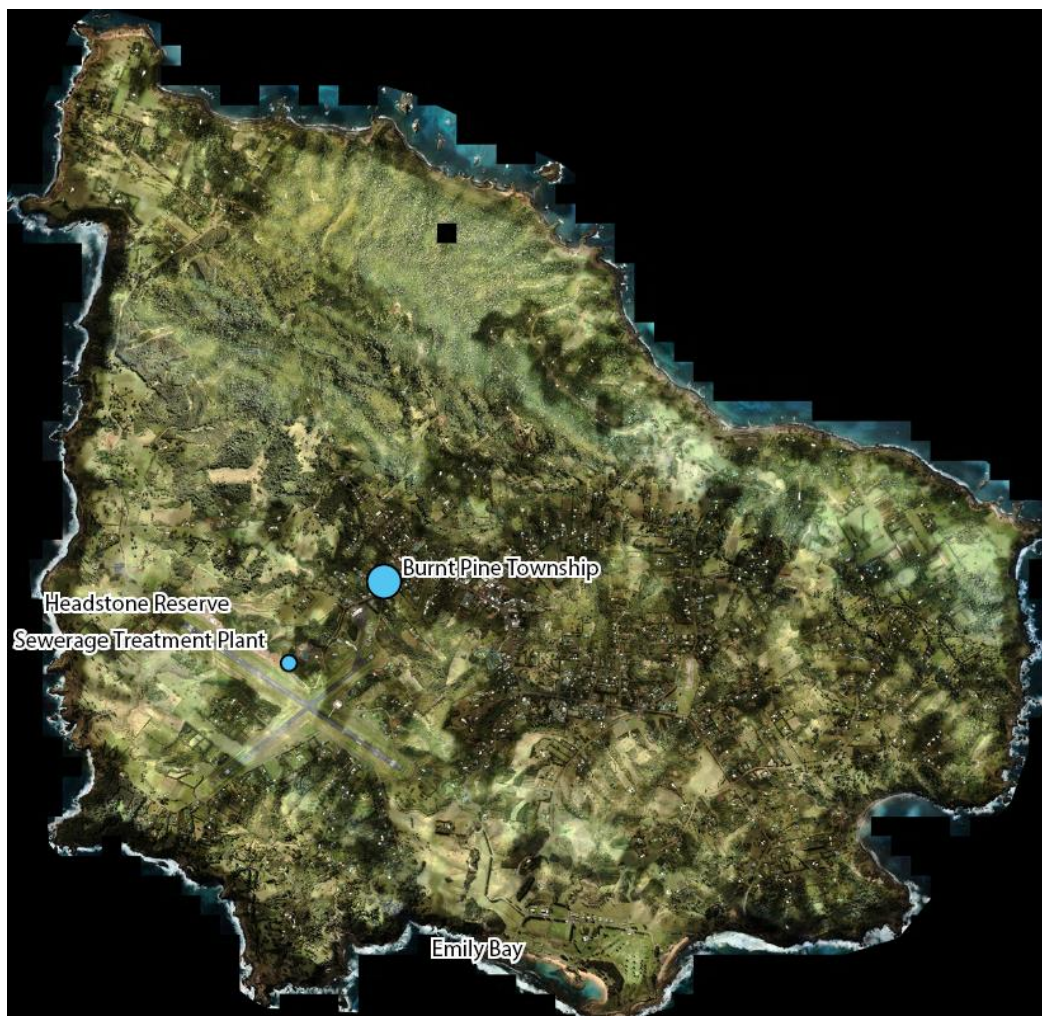
Emily and Slaughter Bay on the southern coast receives runoff from the Upper Cascade Creek and Watermill Creek catchments, which are two of the largest catchments on the island. Town Creek is one of the lowest parts of the island and discharges into the bay when the plug is open. Historically, Town Creek drained into a swamp which prevented the direct outflow of surface waters into the bay. This swamp filtered surface water as it percolated into the groundwater system. The channel was first cut to drain the swamp in 1789 (GML Heritage and Context, 2019).

The island is also underlain by an aquifer, which is used for domestic, commercial, and agricultural purposes. Groundwater generally flows south and upwells at the intertidal zone on Emily Bay.

Figure 1: Norfolk Island context map (aerial image provided by CSIRO).

The island's sewerage treatment plant (STP) is located west of *Norfolk Island International Airport* (Figure 1). This is a secondary treatment plant, consisting of a rotating biological contractor and clarifier, but is in extremely poor condition such that "treated effluent quality is only marginally higher quality than raw waste" (Balmoral Group Australia and Public Works Advisory, 2019). Effluent is released into an ocean outfall at Headstone Reserve and undergoes dilution with surrounding ocean waters.

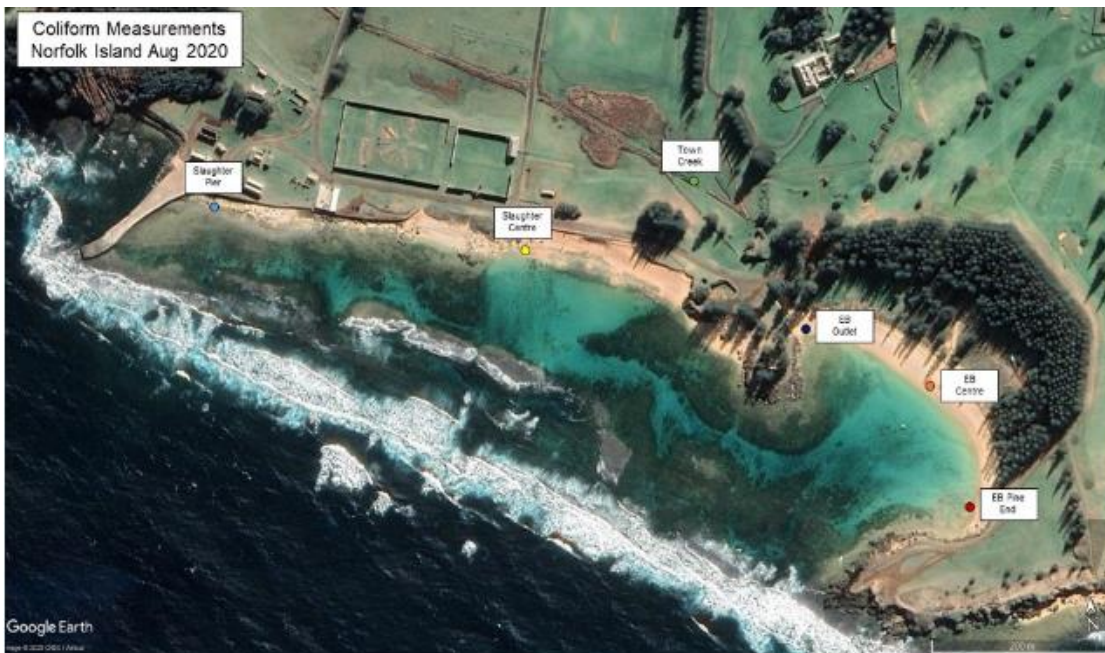
Council has increased the frequency of its water quality monitoring regime as of the 31 July 2020 event. Tests are undertaken at six sites along Town Creek and Emily and Slaughter Bays (Figure 4).

**Figure 4: Water quality testing point locations (NIRC)**

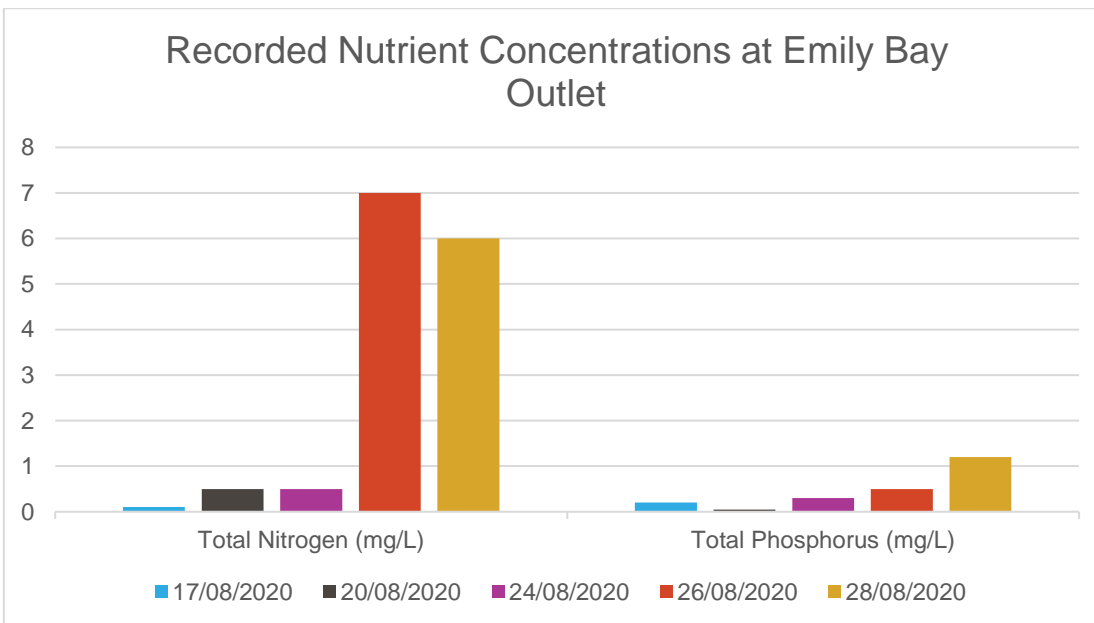
Nitrogen and phosphorus concentrations in Town Creek are below the recording limit of equipment. Interestingly, recordings in the Emily Bay Outlet are higher (Figure 5). This indicates that there could be another source of contamination, such as groundwater seepage.

**Figure 5: Recorded nitrogen and phosphorus concentrations at Emily Bay (NIRC, 2020).**

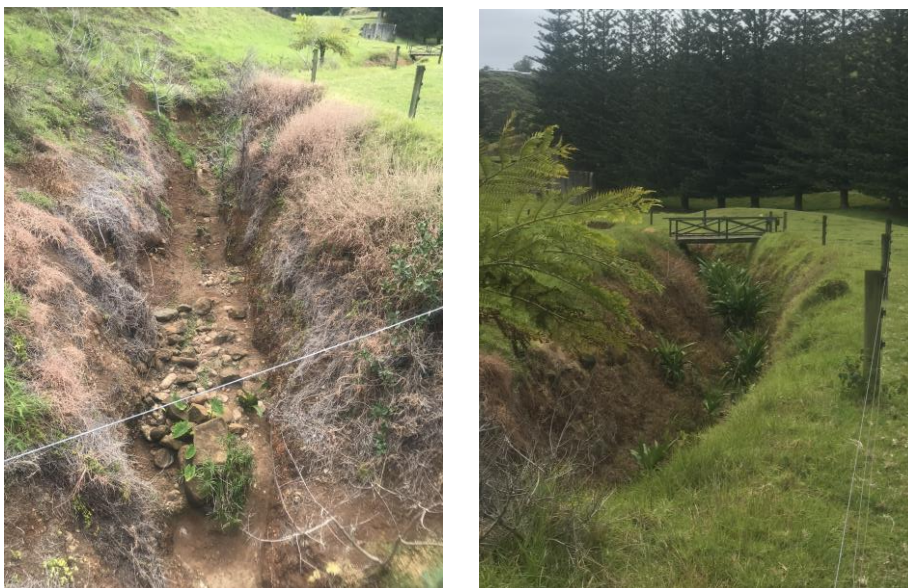
Leaky weirs could be installed downstream of Watermill Dam to attenuate stormwater runoff from the upstream catchment. Leaky weirs can stabilise creek beds to prevent further incising of the creek and reduce sediment runoff. Although sediments have not been highlighted as a key issue, this will provide some relief to the reef. Most notably, this option will not require a development approval or trigger a referral under the EBPC. Lead times should be short, allowing weirs to be installed before December 2020.

**Figure 6: Erosion in Watermill Creek (Wilson, 2020).**

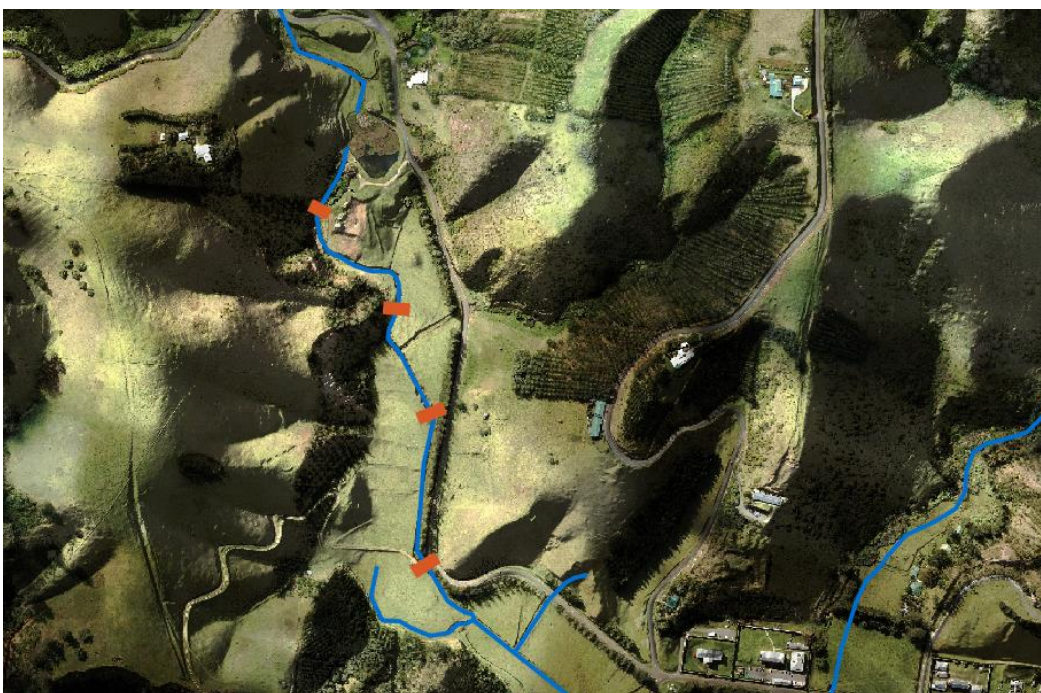
Assuming a channel width of 2.5 m and 2 m tall, wooden leaky weirs are installed, roughly 1000 m<sup>3</sup> could be detained and slowly released. This was indicatively based on the below weir locations, indicative channel widths, and LIDAR data.

**Figure 7: Potential locations to install weirs within Watermill Creek**

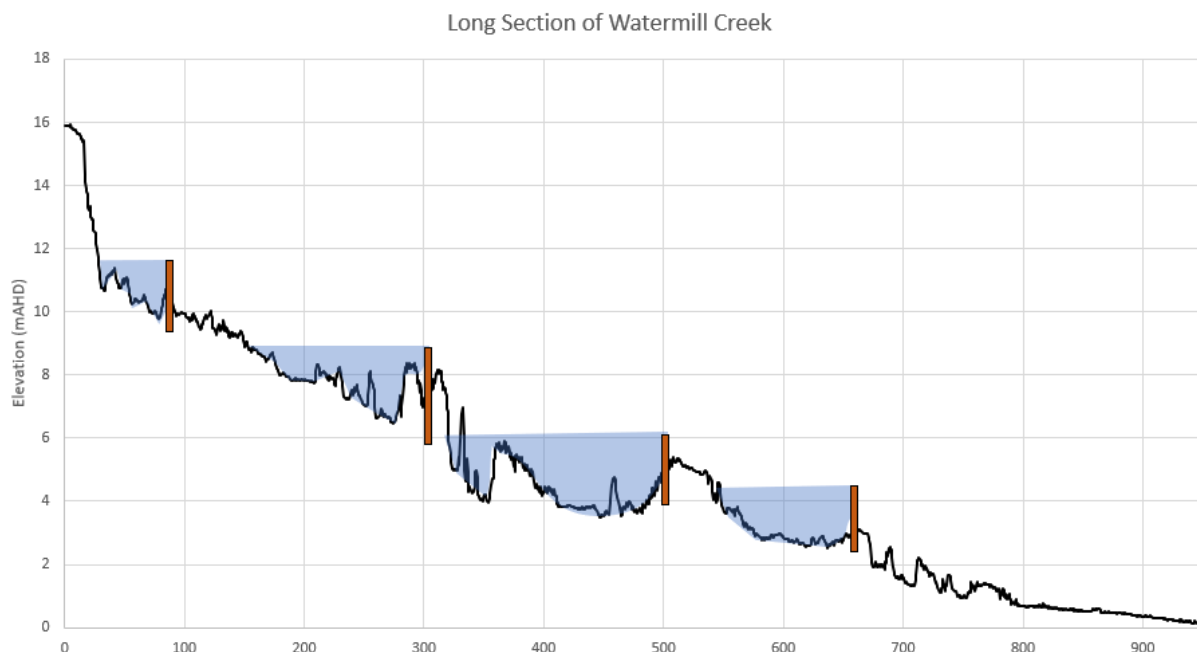
**Figure 8: Indicative channel cross section with leaky weirs**

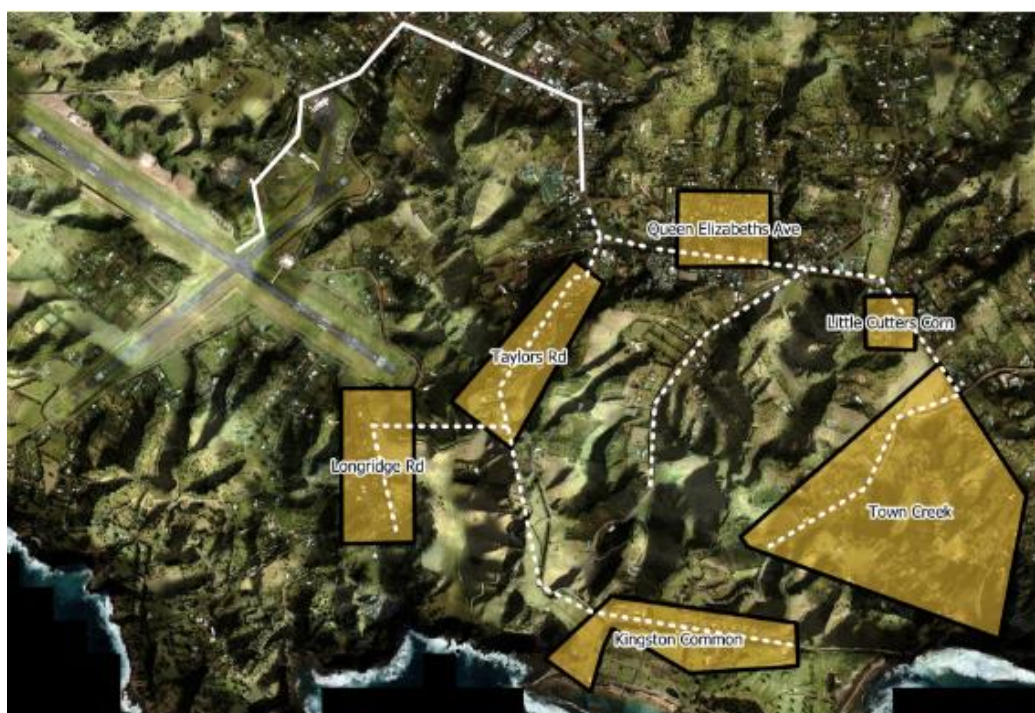
It is recommended for NIRC to expand the *Water Assurance Scheme* to service all properties on the island. Connecting the remaining properties to the STP prevents future contamination of groundwater and allows the denitrification trenches to address the legacy pollution impacts. Should attainment of funding to sewer the entire island be an issue, it is recommended that the high-risk houses in the KAVHA catchment are connected first (Figure below). Indicative costings are provided in Table 1.

Figure 10: Assumed pipeline alignments (proposed alignment is dashed, existing is solid)

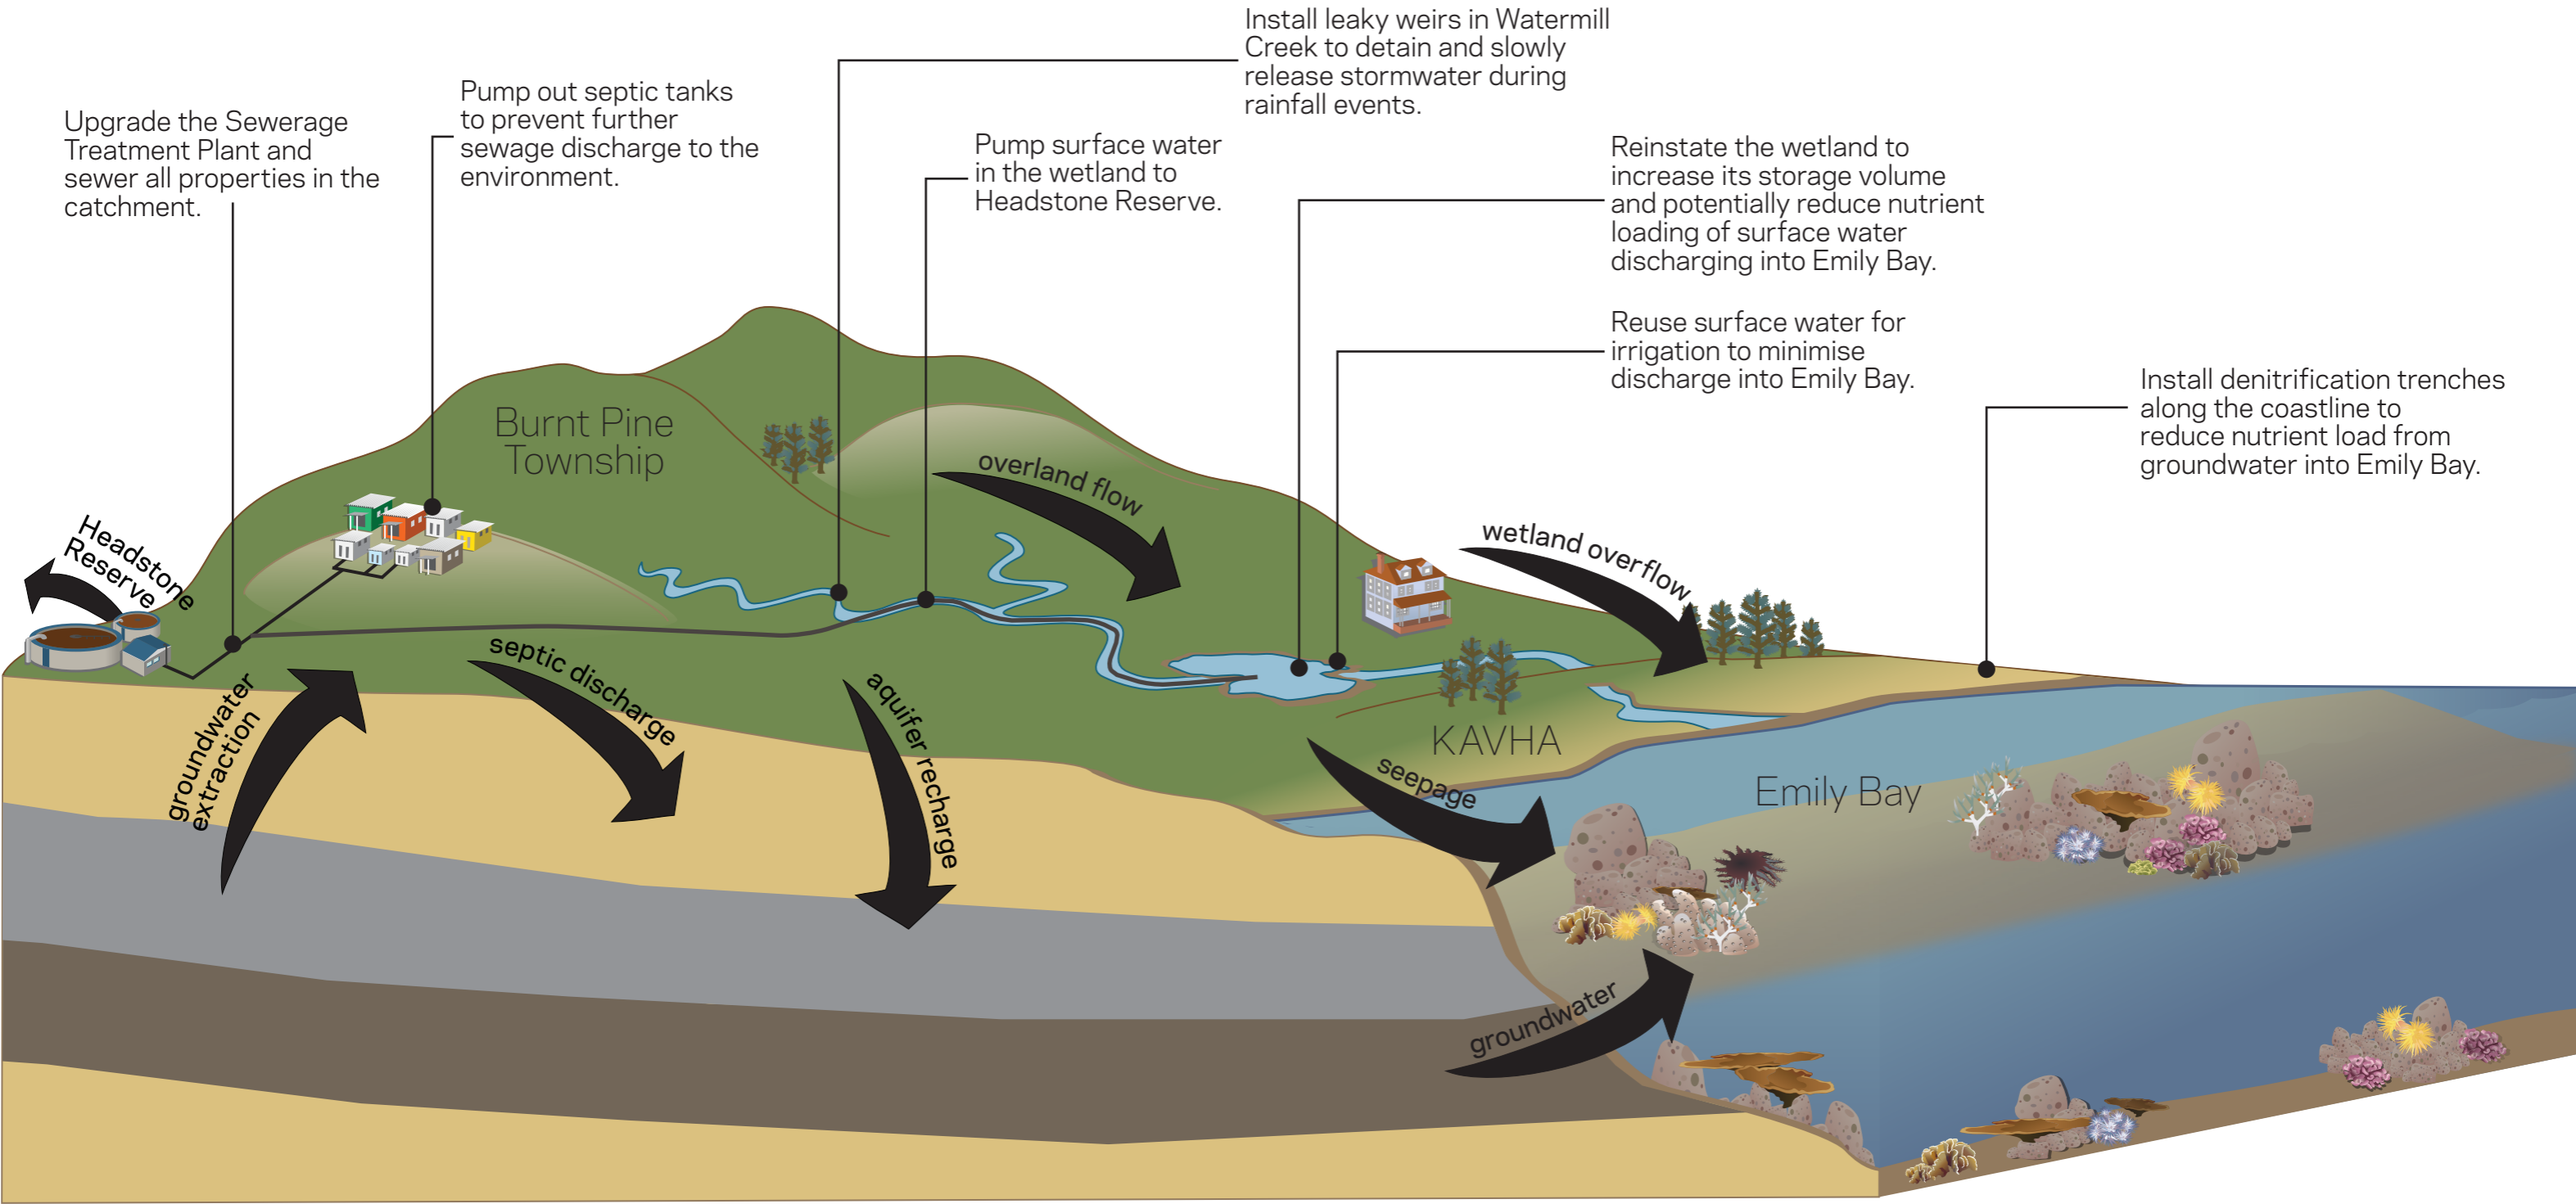
# MANAGEMENT OPTIONS FOR EMILY BAY, NORFOLK ISLAND

Emily Bay is a critical tourist and environmental asset for Norfolk Island. However, a chronic loading of polluted groundwater, the uncontrolled release of contaminated surface water, and increased temperatures have resulted in significant algal overgrowth and coral bleaching in the Emily Bay reef. Immediate action is required to protect the reef from further damage.
